Nazar Tekstil San. ve Tic. A.Ş

Yarn Production Plant

**Environmental and Social
Monitoring Report**

May 2023

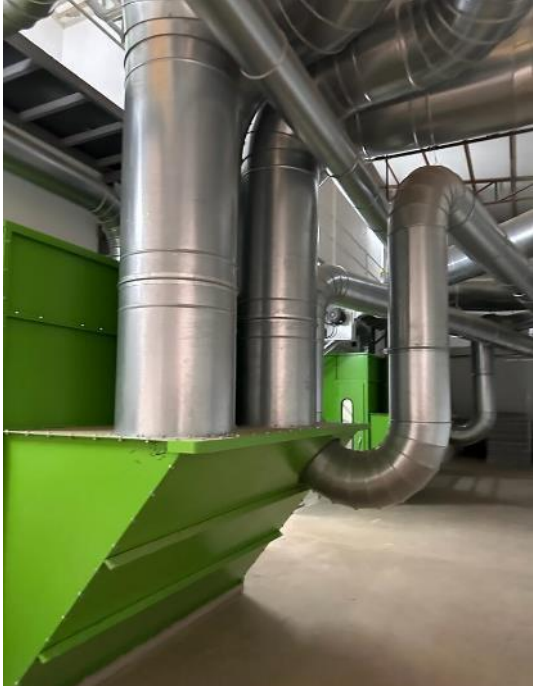
Photographic Log	
Client Name: Nazar Textile		Project Field: Yarn Production Plant Kılılı, Türkoğlu, Kahramanmaraş, Turkey	
		Project No: 01.146.01	
No. 1	Date: 17/05/2023

Project Field: Production Hall			
Description: Manufacturing equipment

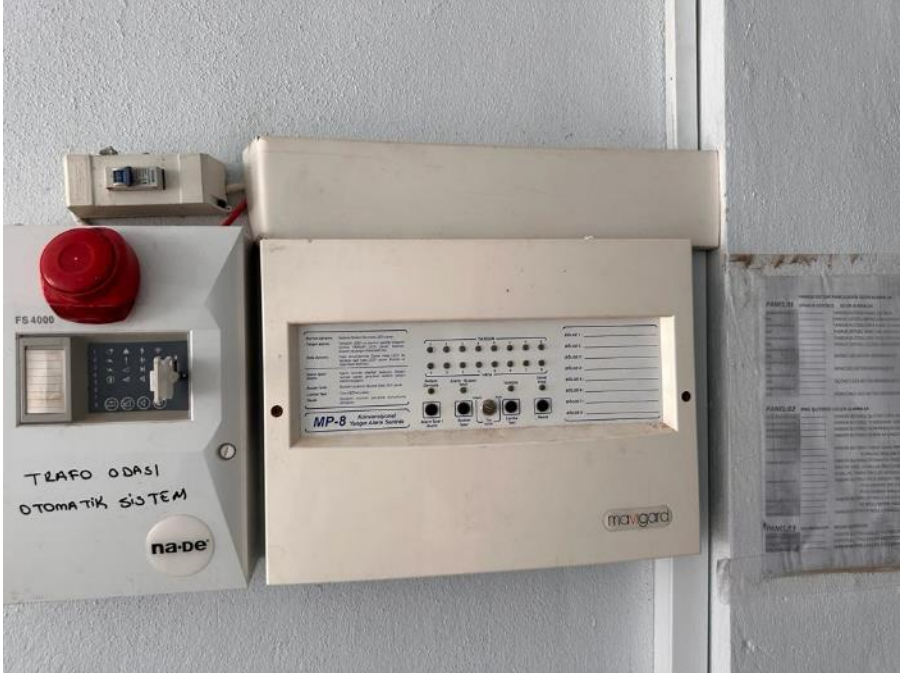
No. 2	Date: 17/05/2023

Project Field: Transformer Unit			
Description: Automatic gaseous fire suppression system.

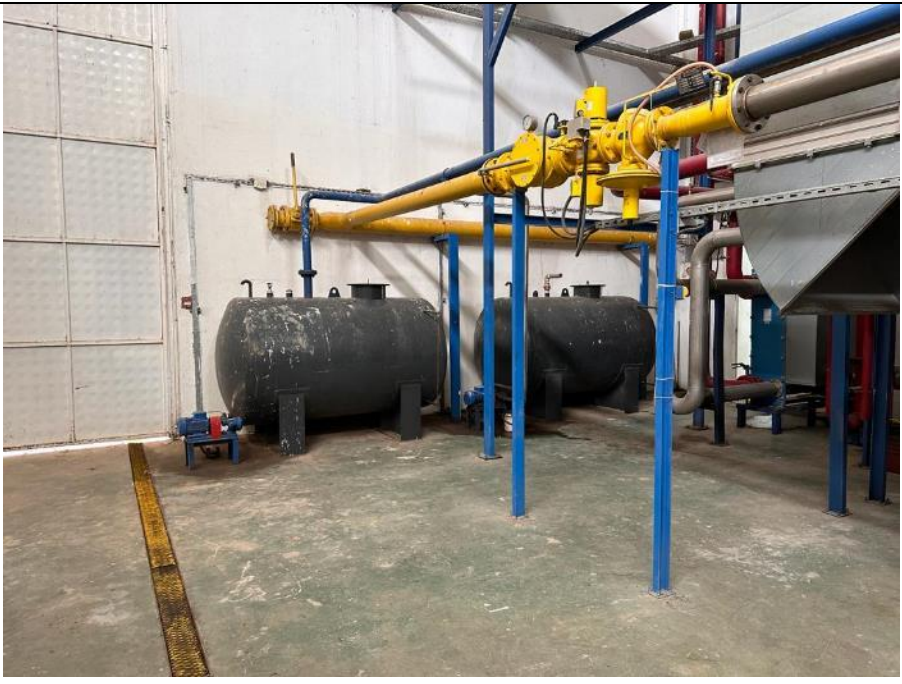
<p>No. 6</p>	<p>Date: 17/05/2023</p>

<p>Project Field: Cogeneration Plant</p>		
<p>Description: Hydraulic oil storage tanks at the cogeneration plant without any secondary containment structure.</p>

- Hydraulic oil storage tanks at the cogeneration plant are observed to be without any secondary containment structure. The spill containment pit of the process area of the cogeneration plant is located outside the building, where stormwater can enter and identified to be full of liquid during the site visit. A secondary containment structure has to be established for the hydraulic oil tanks at the cogeneration plant. Spill containment drainage and pit location has to be reviewed and revised so that there will be no stormwater entering the pit.

3.4	Hydraulic oil storage tanks at the cogeneration plant are observed to be without any secondary containment structure. The spill containment pit of the process area of the cogeneration plant is located outside the building, where stormwater can enter and identified to be full of liquid during the site visit.	A secondary containment structure has to be established for the hydraulic oil tanks at the cogeneration plant. Spill containment drainage and pit location has to be reviewed and revised so that there will be no stormwater entering the pit.	December 2023	HSE Department, Site Management

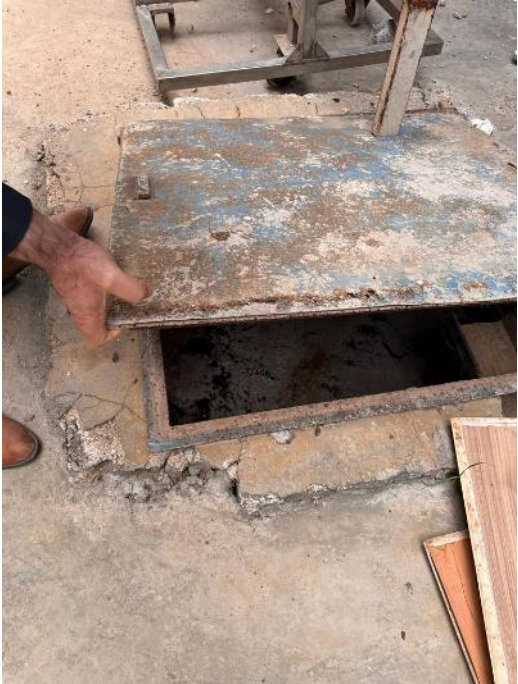
<p>No. 7</p>	<p>Date: 17/05/2023</p>

<p>Project Field: Cogeneration Plant</p>		
<p>Description: The spill containment pit of the process area of the cogeneration plant outside the building, where stormwater can enter and identified to be full of liquid during the site visit.</p>

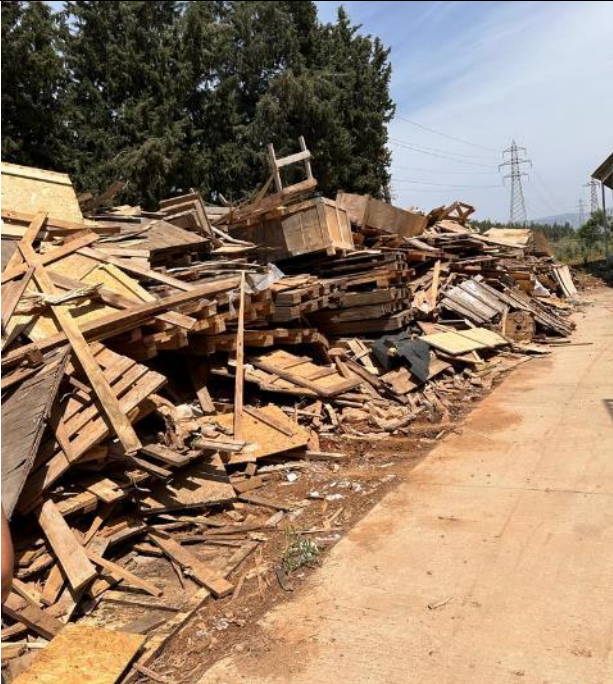
<p>No. 8</p>	<p>Date: 17/05/2023</p>

<p>Project Field: Waste Storage Area next to the raw material storage area.</p>		
<p>Description: Wooden waste pallets next to the raw material storage area where there is no fire extinguishing means available.</p>

2.2	LPG cylinders are observed to be not secured at the LPG cylinder storage area. Wooden waste pallets next to the raw material storage area where there is no fire extinguishing means available.	Periodical control report for air conditioning systems has to be conducted for the year 2023. LPG cylinders have to be secured. Wooden wastes have to be periodically transferred to licensed recycling companies to prevent any fire risks associated with them.	During operational period	Health and Safety Department and Site Management
